**HOLIDAY INN EXPRESS PROJECT  
YPSILANTI CHARTER TOWNSHIP  
Washtenaw County, MI**

**ANANT PATEL**

**Wetland Delineation Report**

January 2024

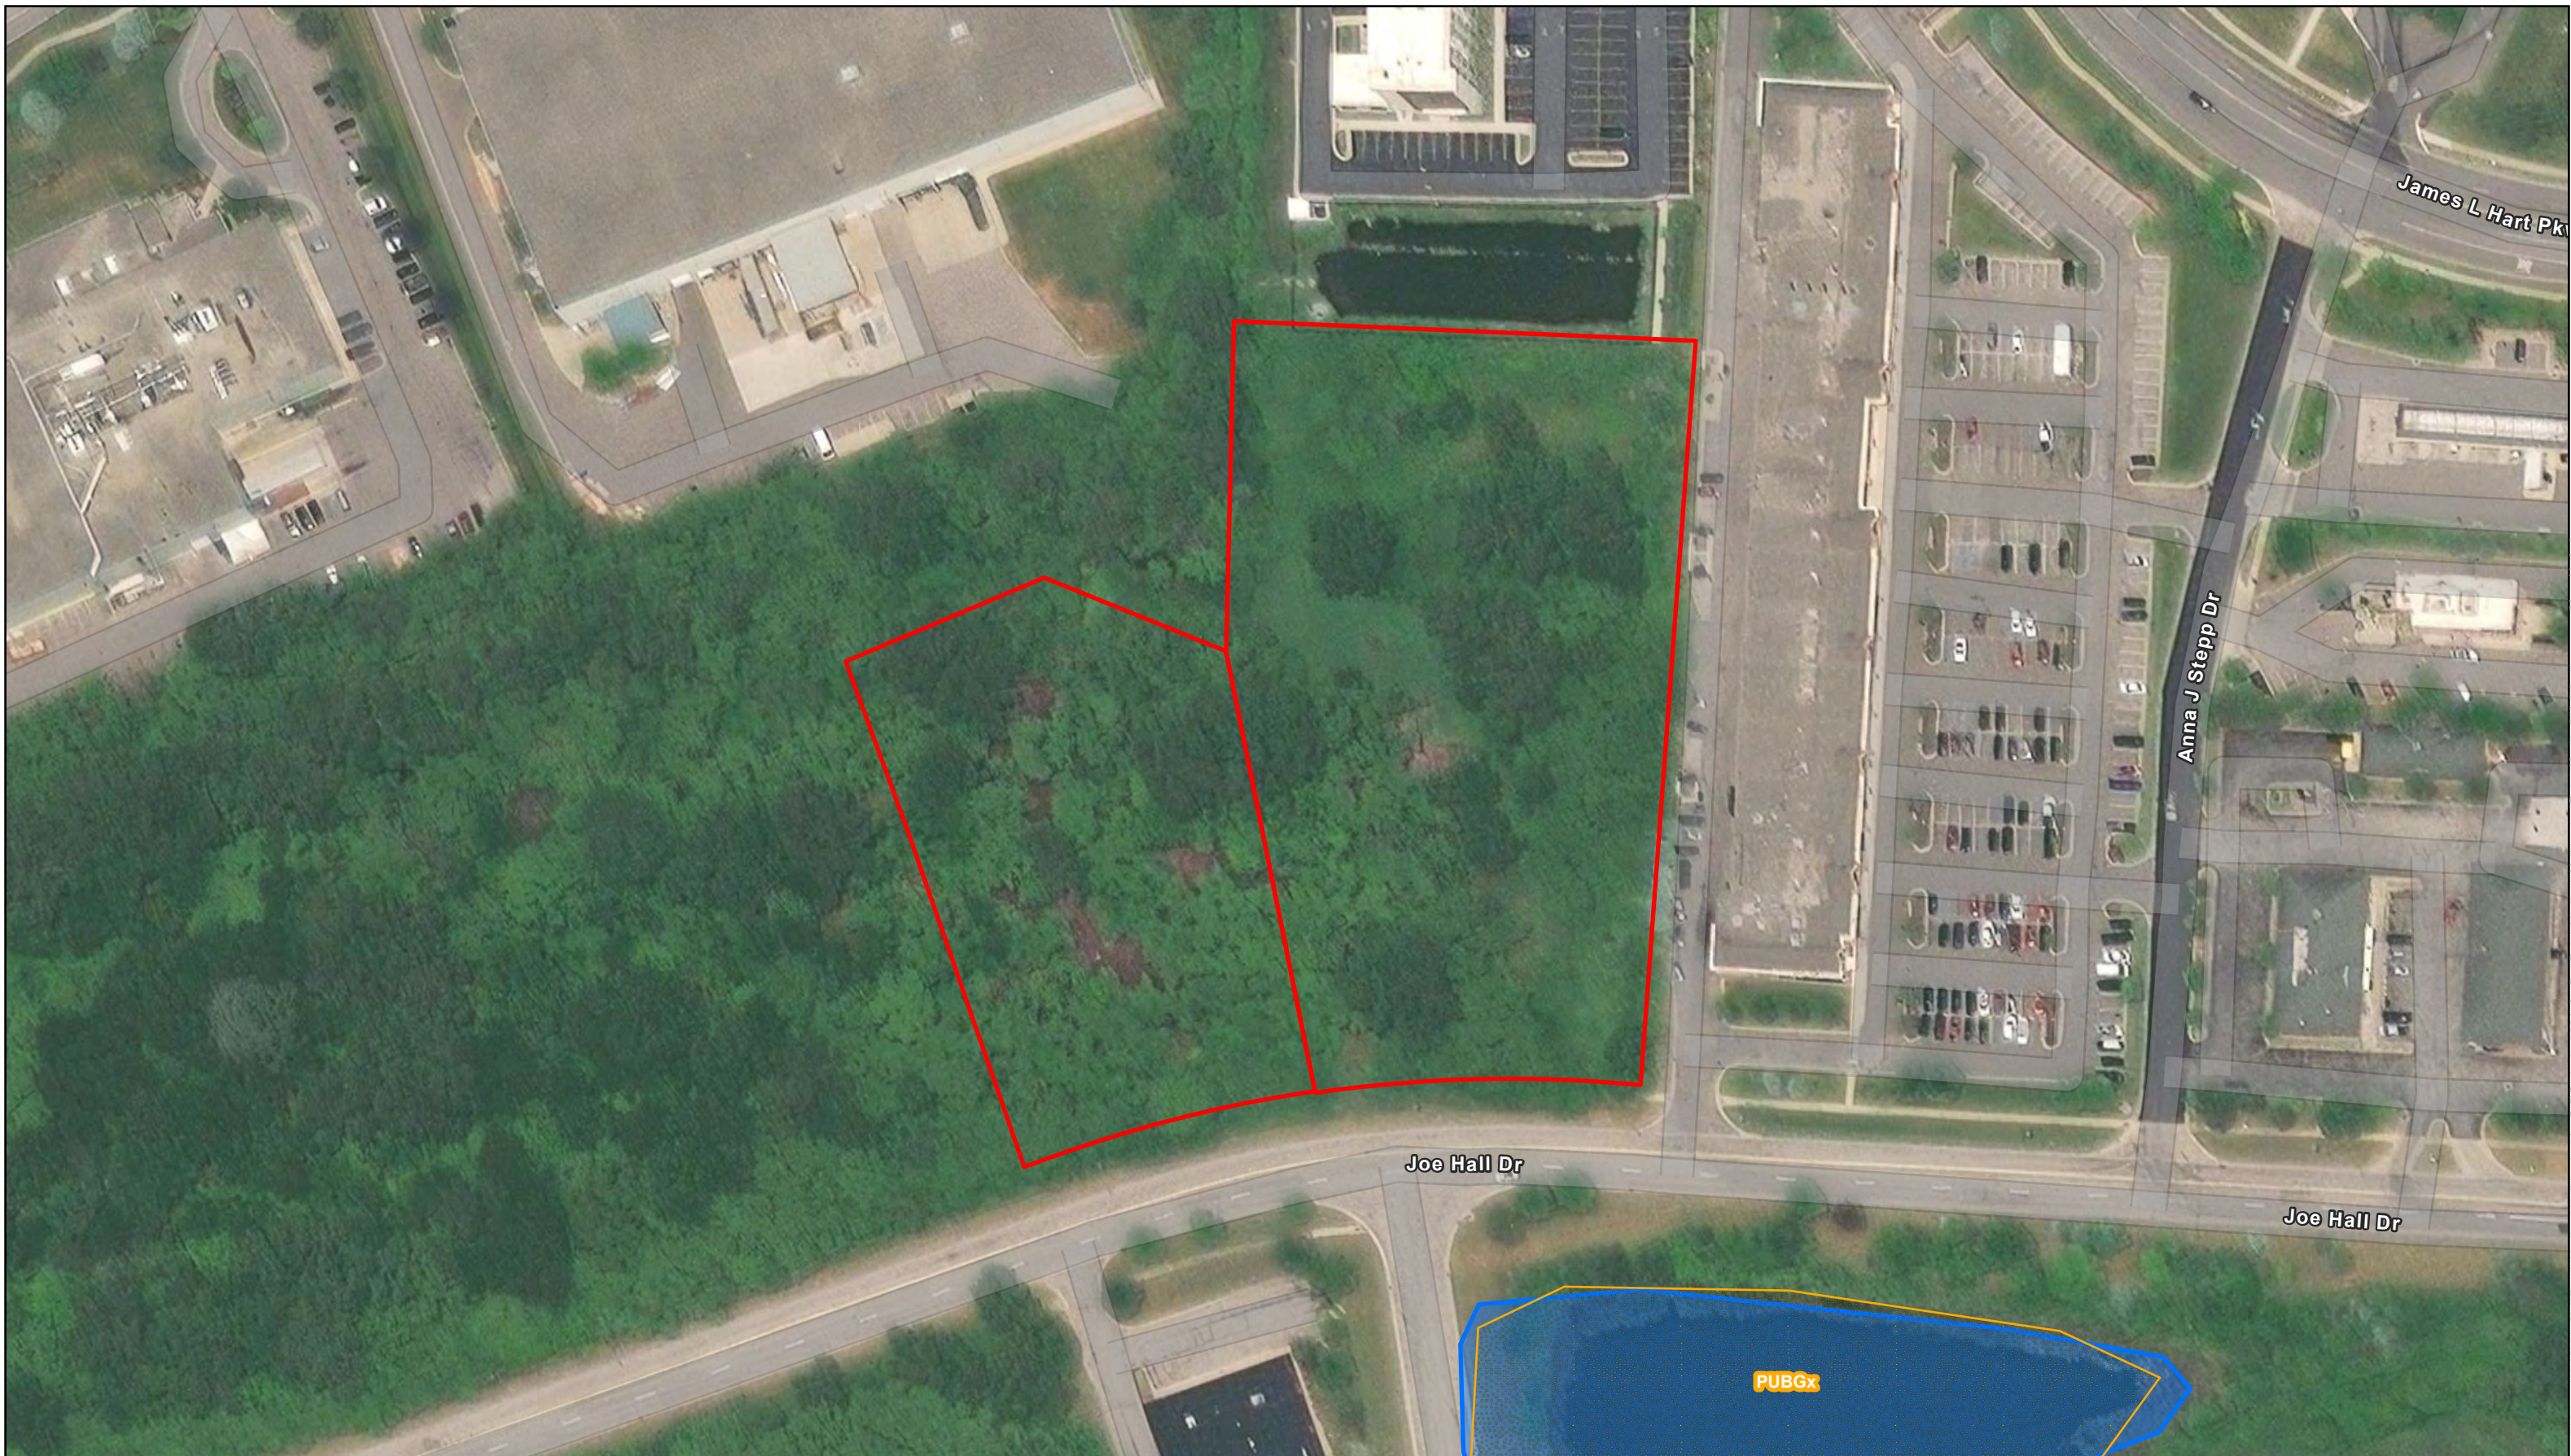
**Figure 4**  
**Hydrology**

The hydrology map (Figure 4) displays no NWI or NHD features within the survey area. An excavated freshwater pond is located southeast of the survey area.

The National Wetlands Inventory (Figure 4; NWI; United States Fish and Wildlife Service [USFWS], 2021) is a nation-wide layer developed locally to remotely identify wetland areas based on additional background information. Portions may be updated at the state or county level at various time intervals, and some may be field verified in select locations.

The USGS National Hydrography Dataset (Figure 4; NHD; USGS, 2004) is the most up-to-date and comprehensive nationwide dataset for rivers, streams, canals, lakes, ponds, coastline, dams, and stream gages. While originally developed by the Environmental Protection Agency (EPA) and USGS, it is now maintained and updated by multiple regulatory bodies.
